# Safety Inspection Report

Annual Inspection

## Wentworth Play Park

24 April 2023

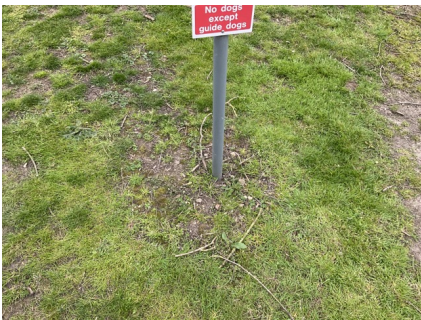
| Description |
|---|
| Loose in ground. |
| Sign post is loose in the ground. Reset. |

| Description |
|---|
| Reset. |

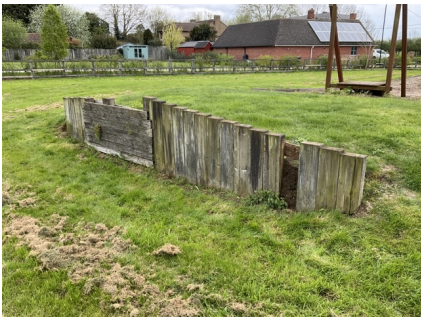
Timber is decayed.

Timber sleepers rotting at ground level. Monitor and replace as required or remove and regrade bank.

Read the notes for further action.

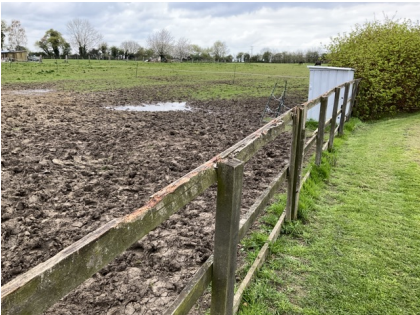
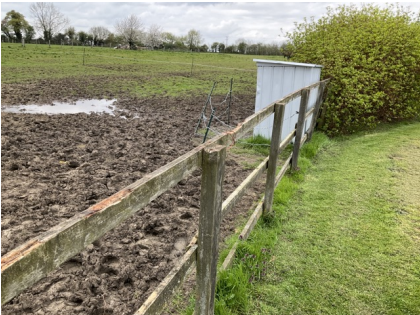
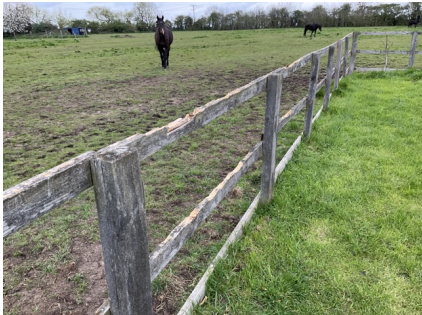
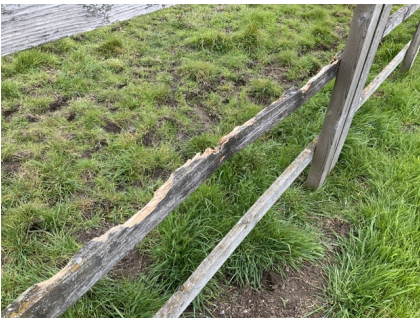
Moderate repairs are needed.

Damaged fence rails. Replace.

Repair.

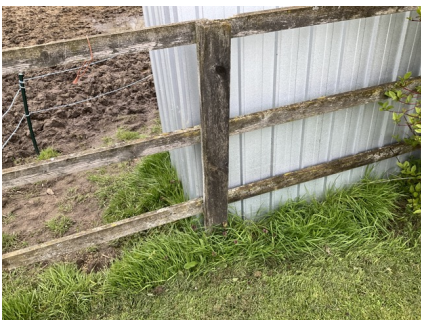
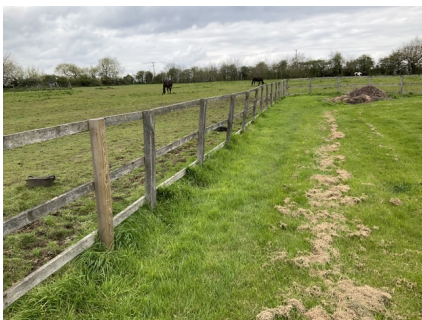
Timber is decayed.

Several timber fencing posts are decayed and loose in the ground. Replace the affected areas.

Check on a routine basis., Replace affected parts.

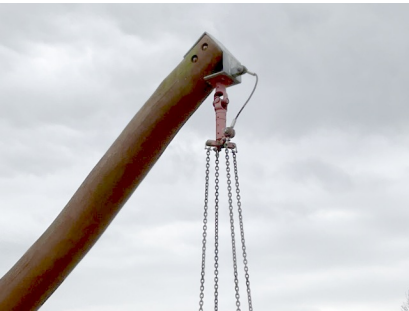
The supporting components should be dismantled and inspected according to the manufacturer's instructions. This will need doing on a regular basis. This can lead to a high risk if no action is taken.

Dismantle and inspect according to manufacturer's instructions.

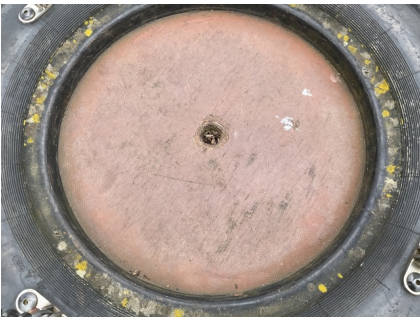
Laminate damaged.

Centre of the swing seat timber is delaminating. Smooth off and treat.

Rub down and treat damaged edges.

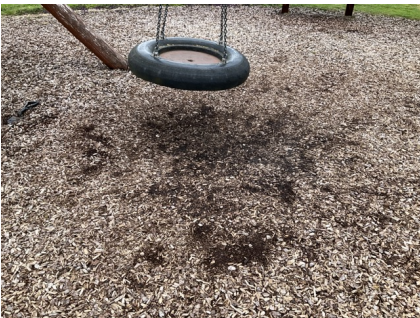
Loose fill levels are too low to provide adequate protection.

Approximately 80 mm provided below the seat.

Rake and fork over and top up as required to maintain minimum depth (usually 300 mm).

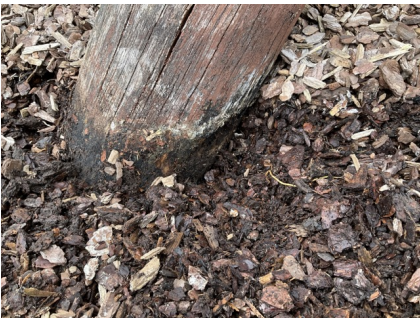
The sapwood of the timber is decaying, which presents softness to the outside of the timbers.

The exterior of the support post is softening due to sapwood. Consider having a resistance penetrating test on the timbers to check for internal decay.

We recommend resistance penetration testing to determine the internal condition of the timber. We can undertake this testing at additional cost. Please contact us for details.

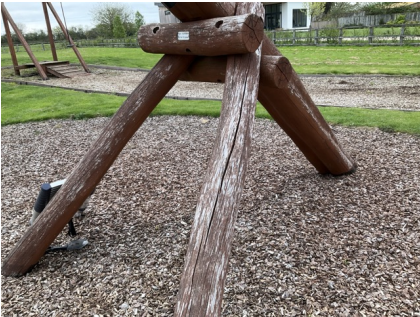
There are natural splits / shakes in the timbers.

Monitor natural timber shake close to the fixings, as these may work loose and regular tightening may be required.

Shakes vary. Monitor and consult manufacturer if dimensions exceed 8 mm at sections used to grip / grasp., Monitor and sand back any splintered edges as required.

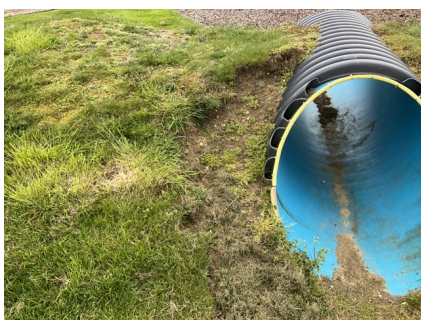
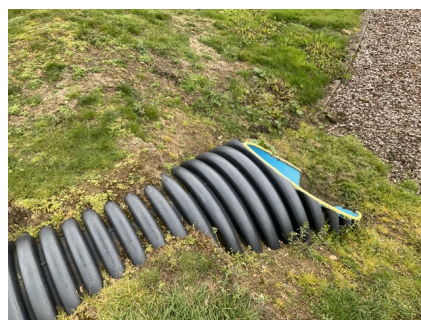
The item complies with the requirements of the relevant standards.  
The surfacing is not compliant with the requirements of the relevant standards.

Make good., Consider adding grass matting to prevent wear.

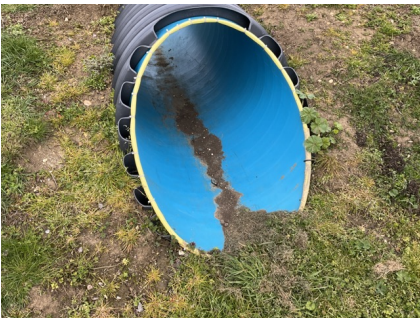
A protective surface is required.

Tunnel mound is easily accessible to the top of the tunnel section, with a 850 mm fall height onto the tunnel's plastic framework.

Install a surface compliant to EN.

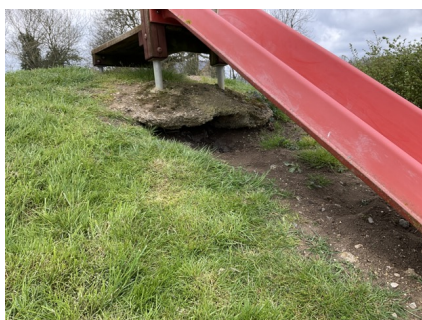
Ground erosion present.

Repair the worn areas.

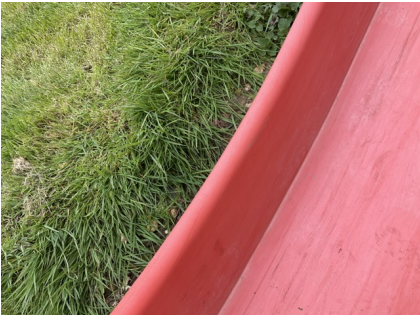
The slide surface is starting to degrade / crack. Monitor on a routine basis.

Monitor.

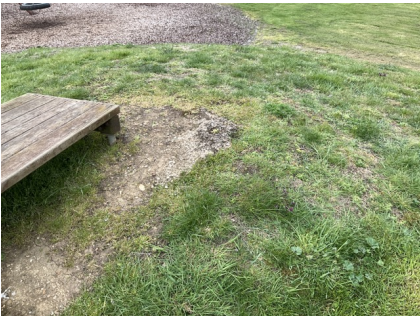
Trip points on the surface.

Make level.

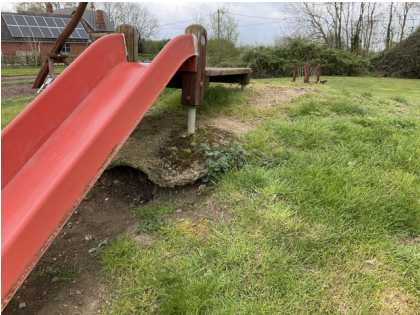
The safer surface has hard edging / foundation within the impact area.

Concrete foundations are exposed, creating a hard surface to fall onto.

Modify to remove the hazard.

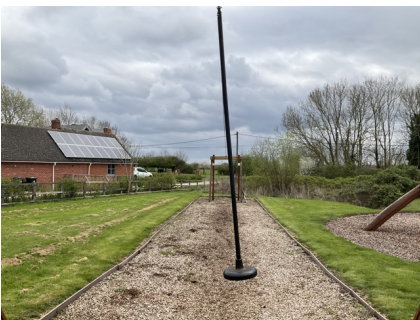
Chain covers prevent a thorough inspection of all chain links.

Remove chain covers to inspect according to manufacturer's instructions.

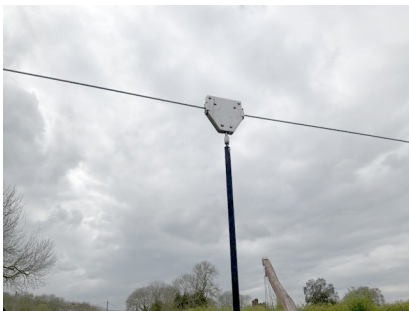
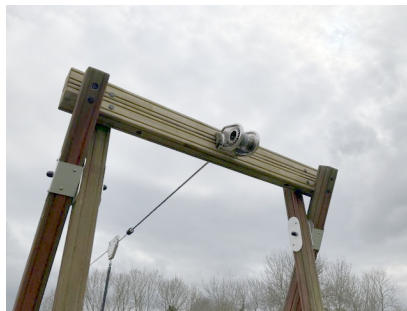
The supporting components should be dismantled and inspected according to the manufacturer's instructions. This will need doing on a regular basis. This can lead to a high risk if no action is taken.

Dismantle and inspect according to manufacturer's instructions.

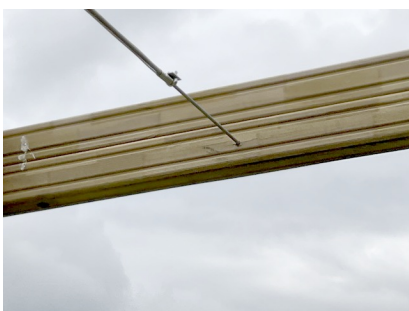
Cables have been known to fail under load due to wear and corrosion. This is generally where the cable enters into a tube, top bar, sleeve or similar, where the wire is in contact and wears and frays over time, but can happen anywhere on the cable. It is important to inspect any hidden parts at least annually. Damaged cables require replacement. This cannot be determined during an annual inspection, and is excluded from our inspection. This can lead to a high risk if no action is taken. Refer to the manufacturer's instructions to ensure the correct check is carried out.

Dismantle the cableway on a routine basis to check for internal wear / damage.

Conduct an appropriate dismantling inspection.

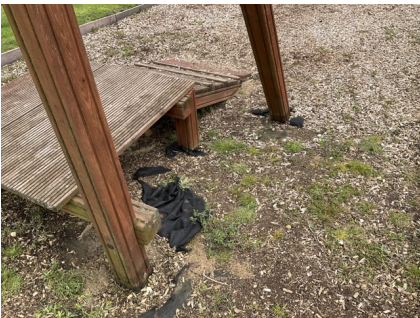
The geo-textile is exposed.

Secure beneath surface and ensure minimum depths are maintained.

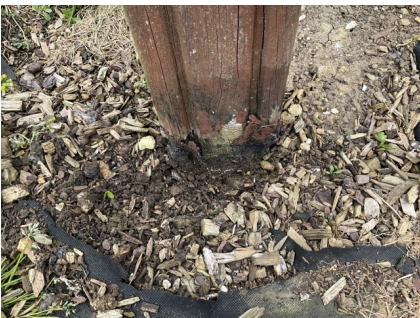
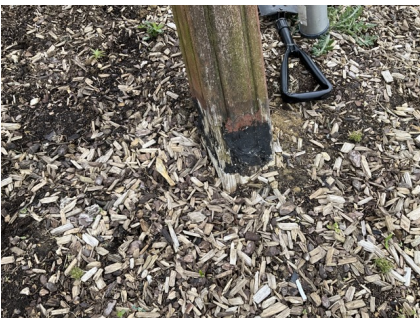
Item is damaged.

There is some damage to the bottoms of multiple uprights. Repairs have been carried out, but our inspector is unable to check for decay in that area. Our inspector recommends having a resistant penetrating test on the timbers to check the conditions of the timber.

Read the notes for further action.

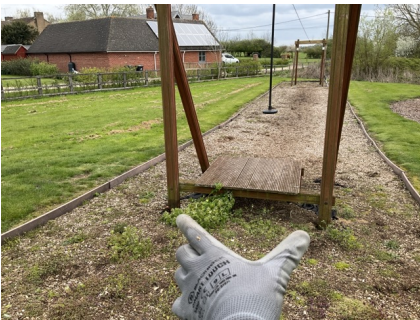
Timber is decayed.

Back supports x 2 on the start station tower are heavily decayed at ground level and require replacement. The two remaining posts are also showing signs of decay, the inspector recommends a resistance penetration test is carried out on these.

We recommend resistance penetration testing to determine the internal condition of the timber. We can undertake this testing at additional cost. Please contact us for details., Replace affected parts.
