# Safety Inspection Report

Annual Inspection

## Wentworth Play Park

24 April 2023

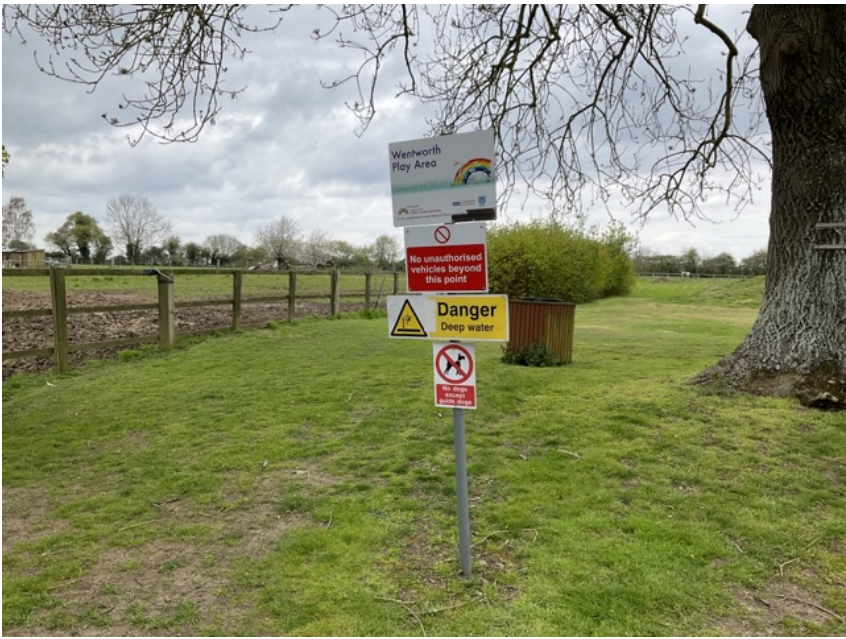
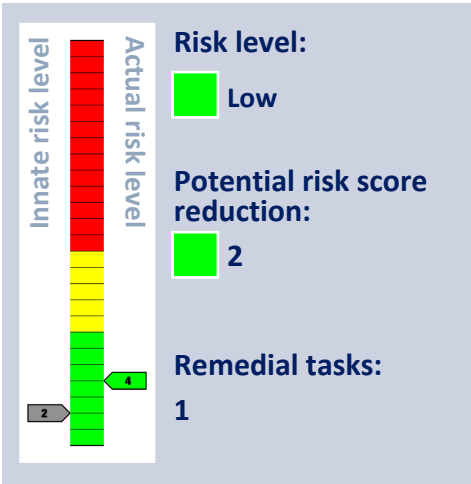
| Description |
|---|
| Loose in ground. |
| Sign post is loose in the ground. Reset. |

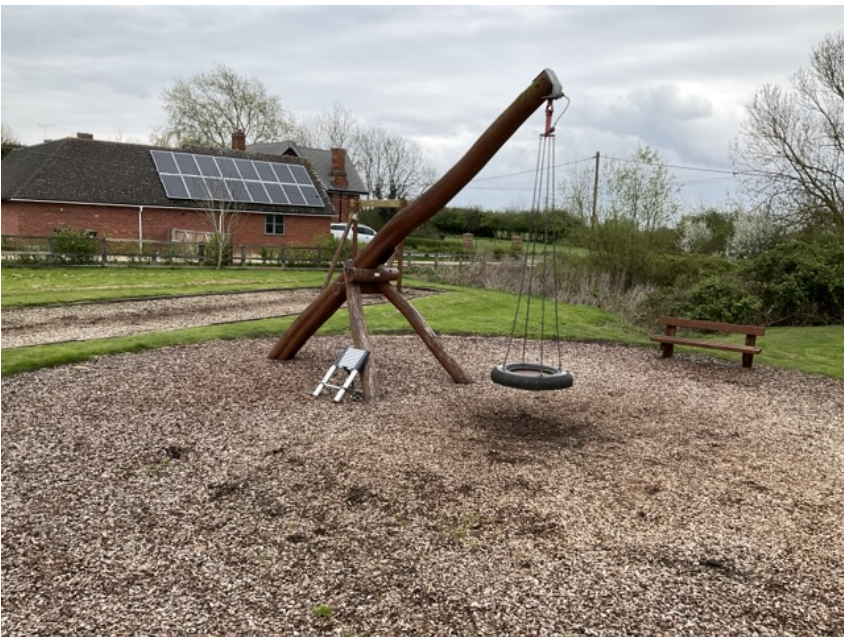
Laminate damaged.

Loose fill levels are too low to provide adequate protection.

The sapwood of the timber is decaying, which presents softness to the outside of the timbers.

The exterior of the support post is softening due to sapwood. Consider having a resistance penetrating test on the timbers to check for internal decay.

Monitor natural timber shake close to the fixings, as these may work loose and regular tightening may be required.

Rub down and treat damaged edges.

We recommend resistance penetration testing to determine the internal condition of the timber. We can undertake this testing at additional cost. Please contact us for details.

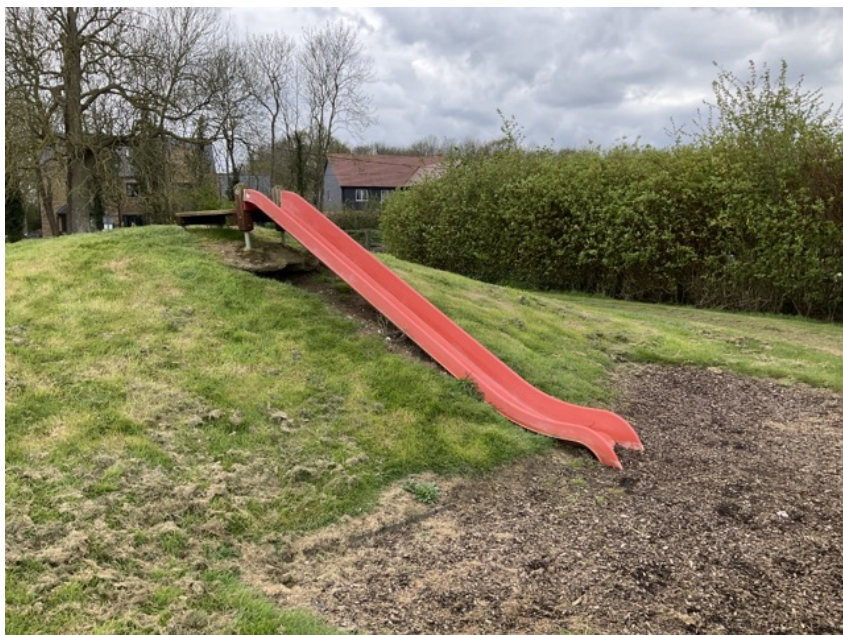
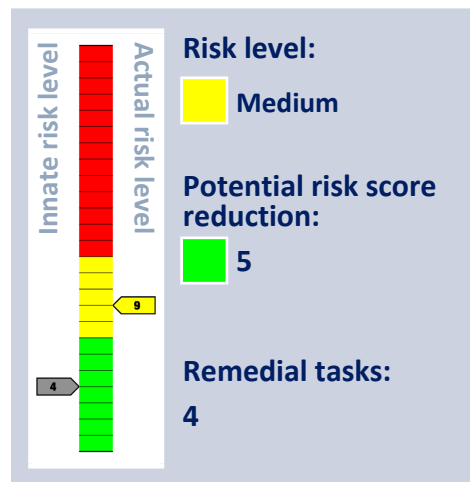
The slide surface is starting to degrade / crack. Monitor on a routine basis.

The safer surface has hard edging / foundation within the impact area.

Concrete foundations are exposed, creating a hard surface to fall onto.

Repair the worn areas.

Modify to remove the hazard.

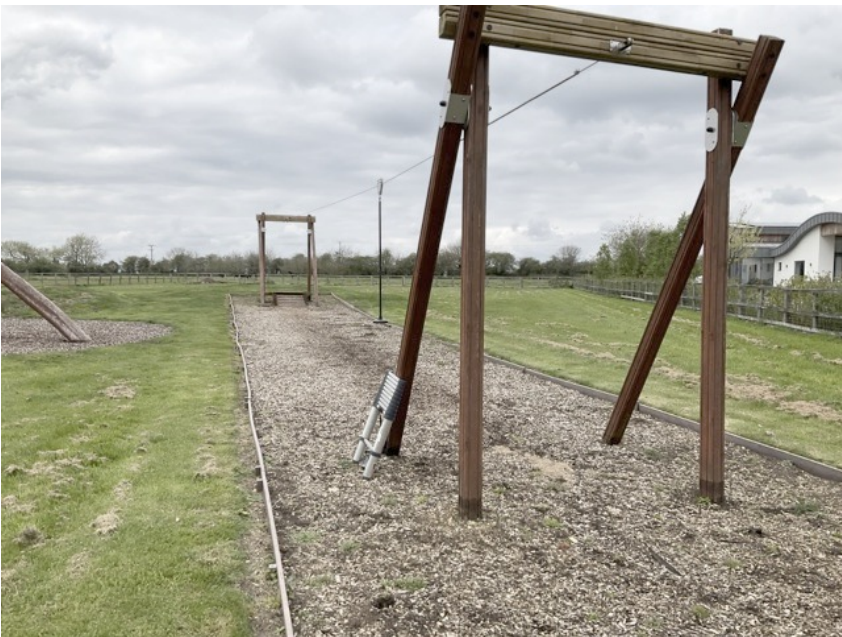
Cables have been known to fail under load due to wear and corrosion. This is generally where the cable enters into a tube, top bar, sleeve or similar, where the wire is in contact and wears and frays over time, but can happen anywhere on the cable. It is important to inspect any hidden parts at least annually. Damaged cables require replacement. This cannot be determined during an annual inspection, and is excluded from our inspection. This can lead to a high risk if no action is taken. Refer to the manufacturer's instructions to ensure the correct check is carried out.

Item is damaged.

There is some damage to the bottoms of multiple uprights. Repairs have been carried out, but our inspector is unable to check for decay in that area. Our inspector recommends having a resistant penetrating test on the timbers to check the conditions of the timber.

Timber is decayed.

Back supports x 2 on the start station tower are heavily decayed at ground level and require replacement. The two remaining posts are also showing signs of decay, the inspector recommends a resistance penetration test is carried out on these.

Dismantle the cableway on a routine basis to check for internal wear / damage.

We recommend resistance penetration testing to determine the internal condition of the timber. We can undertake this testing at additional cost. Please contact us for details., Replace affected parts.
